DROP TEST REPORT

Report No. : ENVA10071604

Product Model Number : S9

ITEM	NAME	HEIGHT	POWER SUPPLY	PACKING	TEST RESULT
1	Free Fall	70 cm	Not applicable	Yes	AA

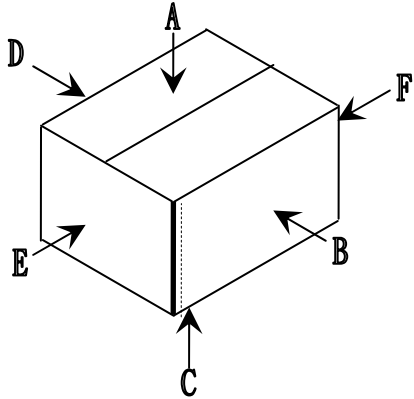
Sequence	Point	Times

1	Bottom Corner B-C-E	1	
2	Edge B-E	1	
3	Edge C-B	1	
4	Edge C-E	1	
5	Face C	1	
6	Face A	1	
7	Face B	1	
8	Face D	1	
9	Face E	1	
10	Face F	1

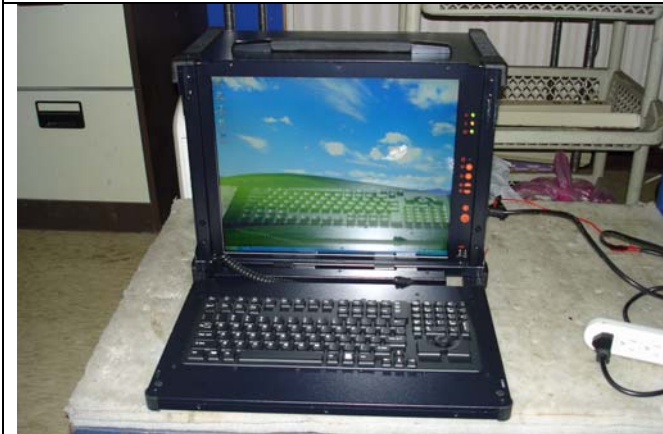
After The Test

The EUT still work after the test.
Please refer to the test record
